Manhole Inspection Summary

Manhole # S07QQ1015MH

Location Address: **5300 PARK HIEGHT AVE** Cross Street: **HAYWARD AVE**

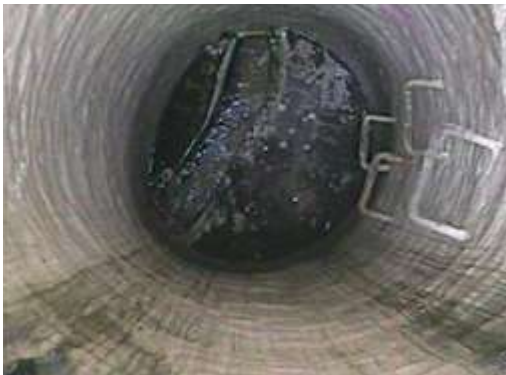
Defect 1

Steps Count: **7** Missing: **1** ☒ **Corroded**

CORRODED STEPS

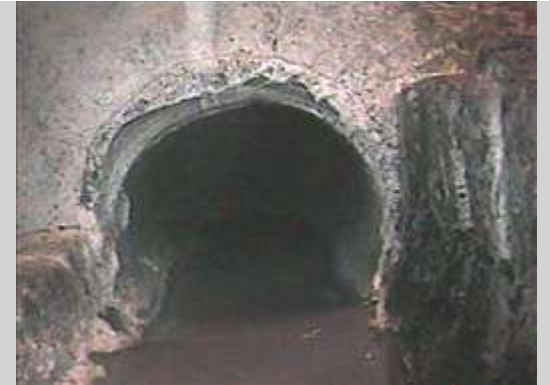
12 O'Clock Outflow

8 in. Circular Gravity Sewer
Pipe Out @ 12 O'Clock

Pipe Height: (in.) Direct
Pipe Material: **Clay** ☐ Pipe Lined
Invert Depth: **14.14** (ft.) Flow Characteristics: **Fast**
Deposits: ☒ None ☐ Mud ☐ Sludge ☐ Debris ☐ Grease
Silt Depth: (in.) Deposits Extent:
Infiltration: **None** Pipe Seal Cond: **Sound**

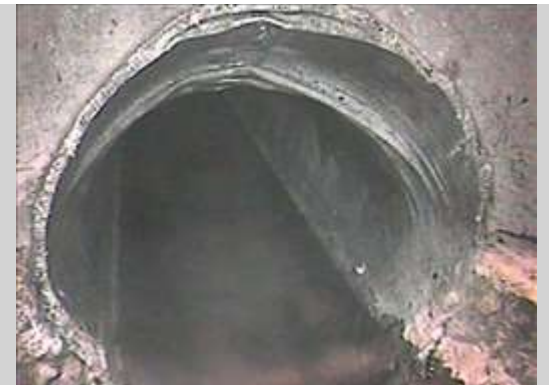
9 O'Clock Inflow

12 in. Circular Gravity Sewer
Pipe In @ 9 O'Clock

Pipe Height: (in.) Direct
Pipe Material: **Clay** ☐ Pipe Lined
Invert Depth: **14.20** (ft.) Flow Characteristics: **Fast**
Deposits: ☒ None ☐ Mud ☐ Sludge ☐ Debris ☐ Grease
Silt Depth: (in.) Deposits Extent:
Infiltration: **None** Pipe Seal Cond: **Sound**
